### SERVICE BULLETIN No. BB/39, BB-S/4

**Inspection of middle hinge of the Ignis burner**  
**Attachment of SB No. BB/39 and No. BB-S/4**

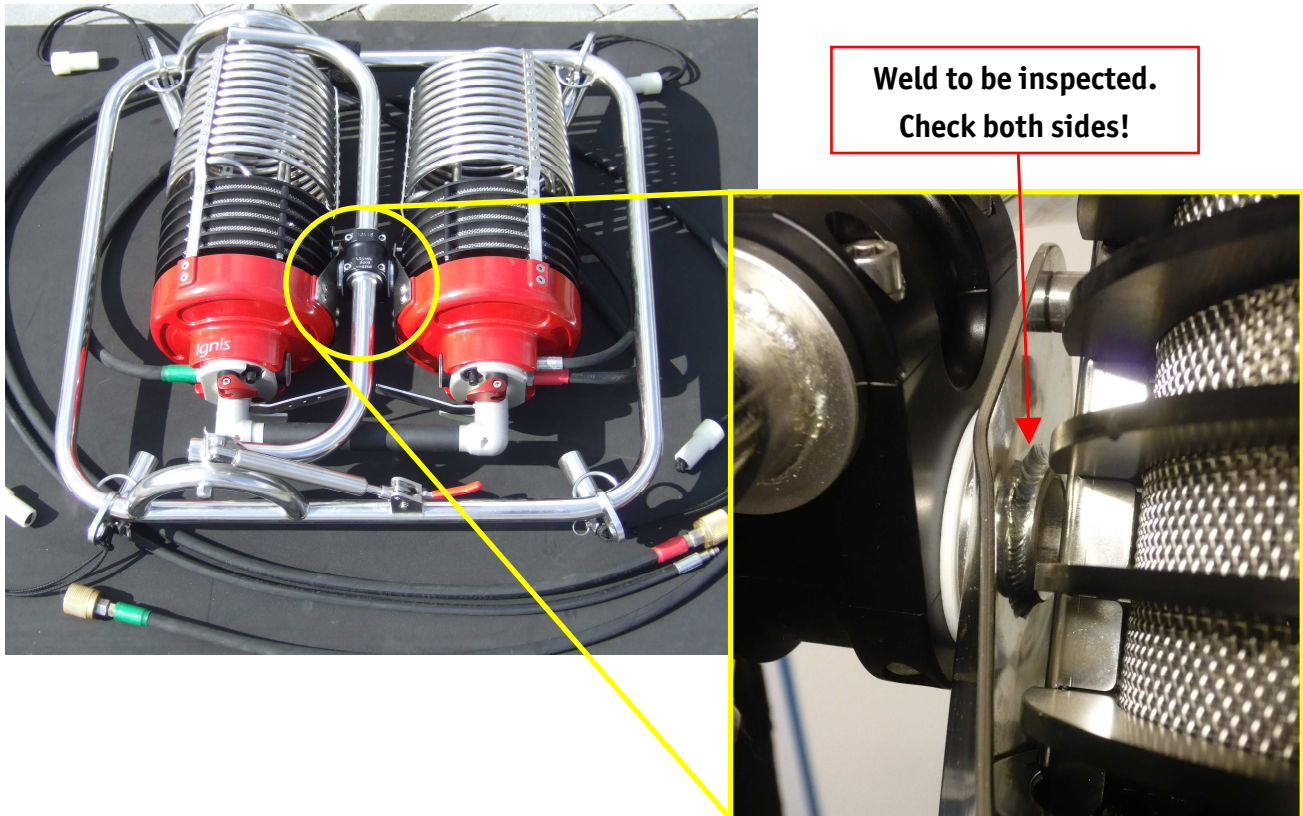
- 2. REASON:** Weld failure have occurred in middle hinge of one Ignis 2-units burner due to inappropriate ground handling, e.g. incorrect transportation of the burner in "ready-to-fly" position without fixing of burner units by handle to the burner frame.

Inspect visually below specified welded joints on both sides of the burner hinge. No part of the burner needs to be removed or disassembled.

Check the weld along its entire length for possible cracks. Use a flashlight to see it well and try to move the burner in the hinge. In case the weld is damaged the burner unit is likely deflected from its correct position and the blast valve lever is not exactly above the handle.

In case any damage has been found contact the factory at [service@kubicekballoons.cz](mailto:service@kubicekballoons.cz) for further instructions prior to next flight.
