SERVICE BULLETIN No. BB/48, BB-S/9, rev. 1

- 1. WITH REFERENCE TO:** All hot air balloons Kubicek S/N 800-1280, except those equipped by single line deflation system.
- 2. REASON:** Discolouration of deflation system control lines has occurred which could impair their distinctiveness.

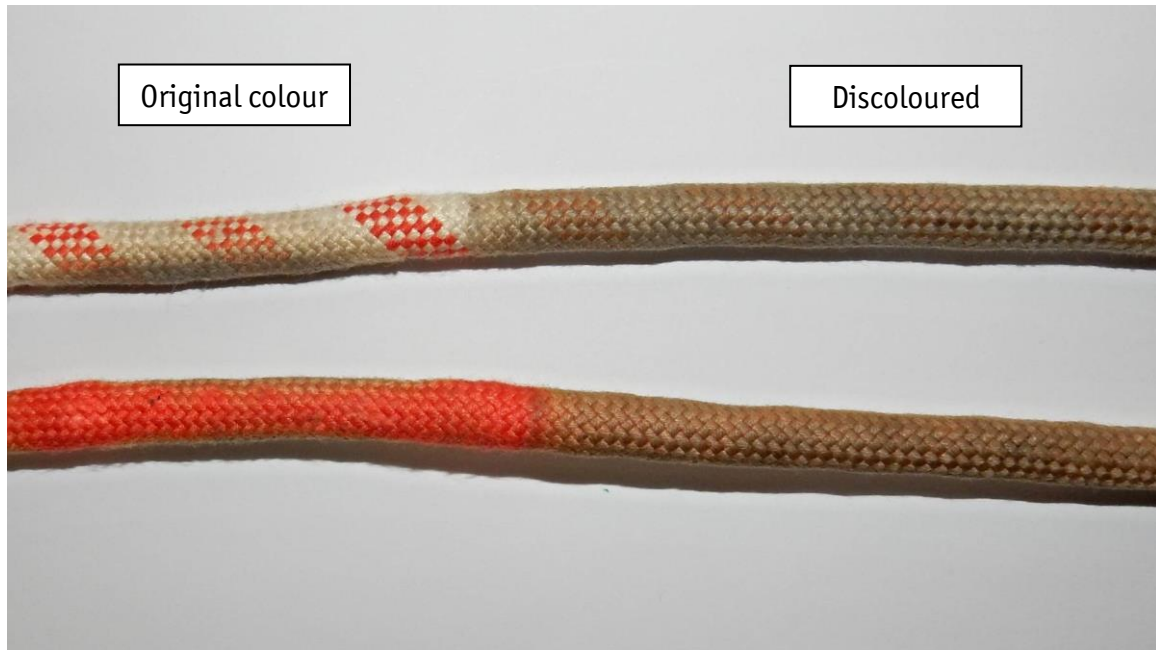
Example of discoloured lines

Here is an example of a red and white line and red line with significant discolouration than disables a simple and unmistakable distinction. Such lines need to be replaced.

- 3. REQUIRED ACTION:** Inspect all deflation control lines to check their colour remains clearly distinguishable. If discolouration occurs (see the photo on the next page), the affected control line(s) must be replaced with a new line.
