KUBÍČEK

SERVICE BULLETIN No. 55

- 2. REASON:** Possible occurrence of envelope tempilabel with wrong temperature range.
- 3. REQUIRED ACTION:** Check of the tempilabel temperature range, exchange where wrong type is fitted.

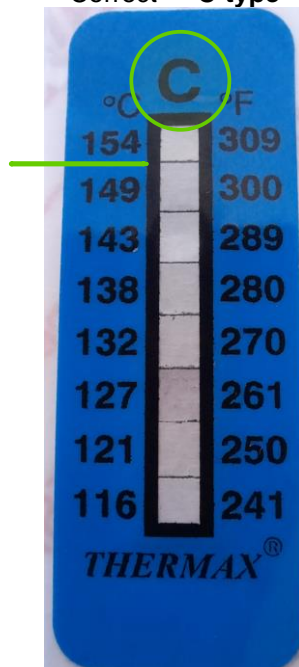
Correct - "C-type"

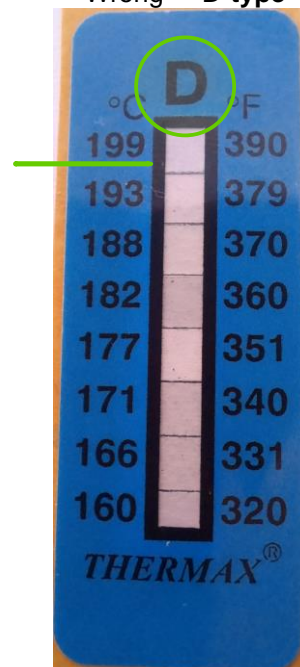
Wrong - "D-type"

- 4. DEADLINE FOR ACTION:** **Check the tempilabel type prior to next flight.**
In case wrong tempilabel (D-type) is found, install the correct (C-type) on the first convenient opportunity, latest during the next annual inspection. However, the balloon is flyable till temperature streamer drops. In such a case, envelope overheat inspection (see MM chapter 7.19.1) must be completed prior to any further flight.

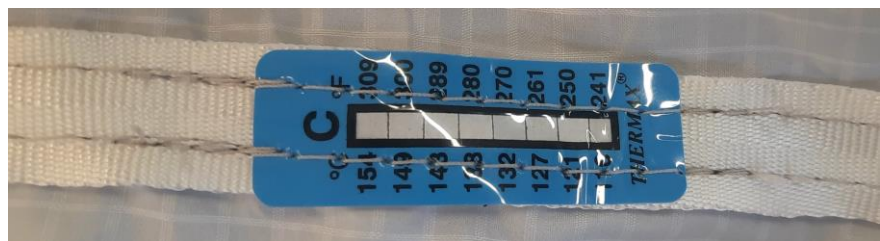
Correct sewing of the tempilabel.

- Performance of envelope overheat inspection according to MM chapter 7.19.1
- Remove the wrong tempilabel.
- Sew the new tempilabel to the same place – see the picture below.

- Remove the wrong tempilabel.
- Sew the new tempilabel to the same place – see the picture below.
