SERVICE BULLETIN No. BB/45

- 1. WITH REFERENCE TO:** Kubicek BB balloons with transparent windows of early design without a tape around the window foil edge (envelope serial numbers: 662, 663, 674, 709, 711, 714)

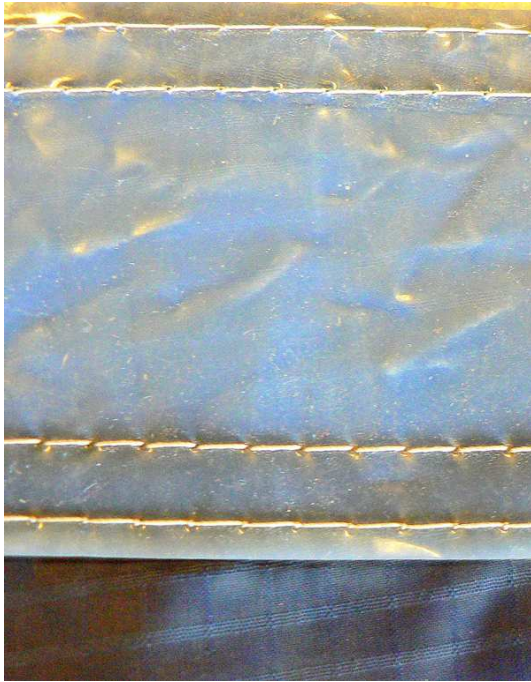
Window without edge tape - AFFECTED

- 2. REASON:** Possibility of damage to the envelope fabric in contact with window foil.
- 3. REQUIRED ACTION:**
1. Extended procedure of the annual / 100 hour inspection: Inspect all transparent envelope windows along their entire perimeter for a damage of the fabric. In case the fabric is worn from the contact with window foil the entire affected panel is to be replaced.

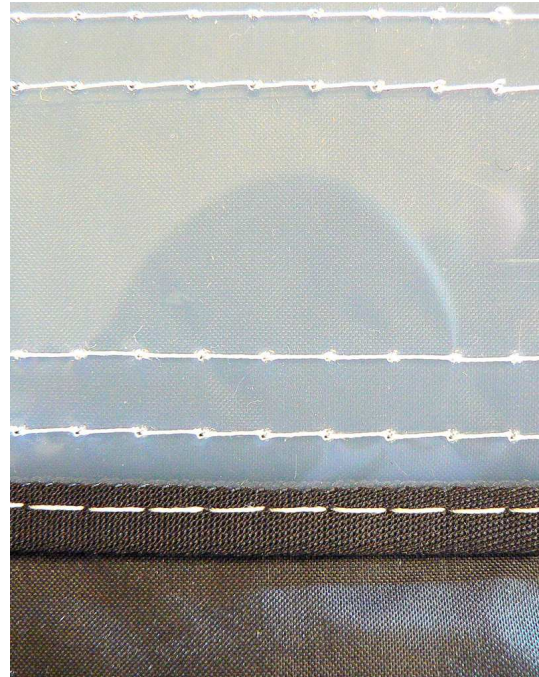
Window with edge tape - NOT AFFECTED
